# IMPROVING SAFETY BY REDUCING SPEEDING

## BUENOS AIRES, ARGENTINA

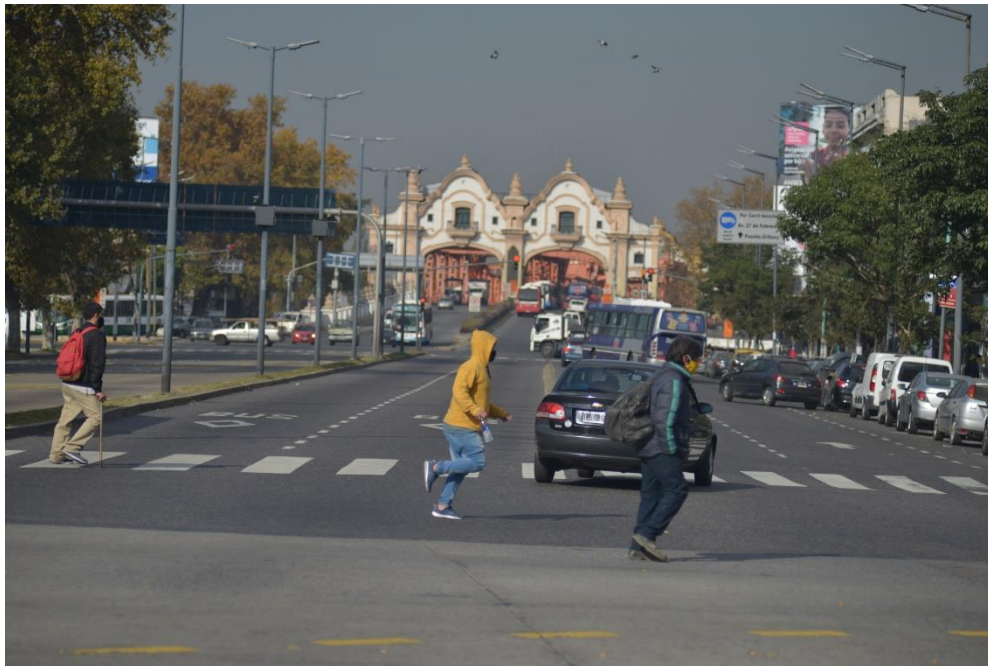
**BEFORE**

**Figure 1:** Images of Saénz before and after the anti-speeding measures.

The Autonomous City of Buenos Aires has been working with the Partnership for Healthy Cities and other local partners to improve the safety of its roads since 2017. The latest project focuses on the high-density Saénz Avenue transport area in the south of Buenos Aires, because of its relatively high rate of pedestrian fatalities. With support from the Partnership, and in collaboration with the World Resources Institute, a series of anti-speeding measures were gradually introduced after the city conducted a 2020 speeding patterns study that identified Saénz as one of four points in the metropolitan area with the highest number of incidents involving pedestrians and vehicle users. The study concluded that approximately 8% of drivers exceeded speed limits and that buses and trucks were more than twice as likely to speed as other vehicles.
